SECTION 19 FLOOD INVESTIGATION: SEPTEMBER 2024 FLOOD EVENT

23 September 2024 Flood Event

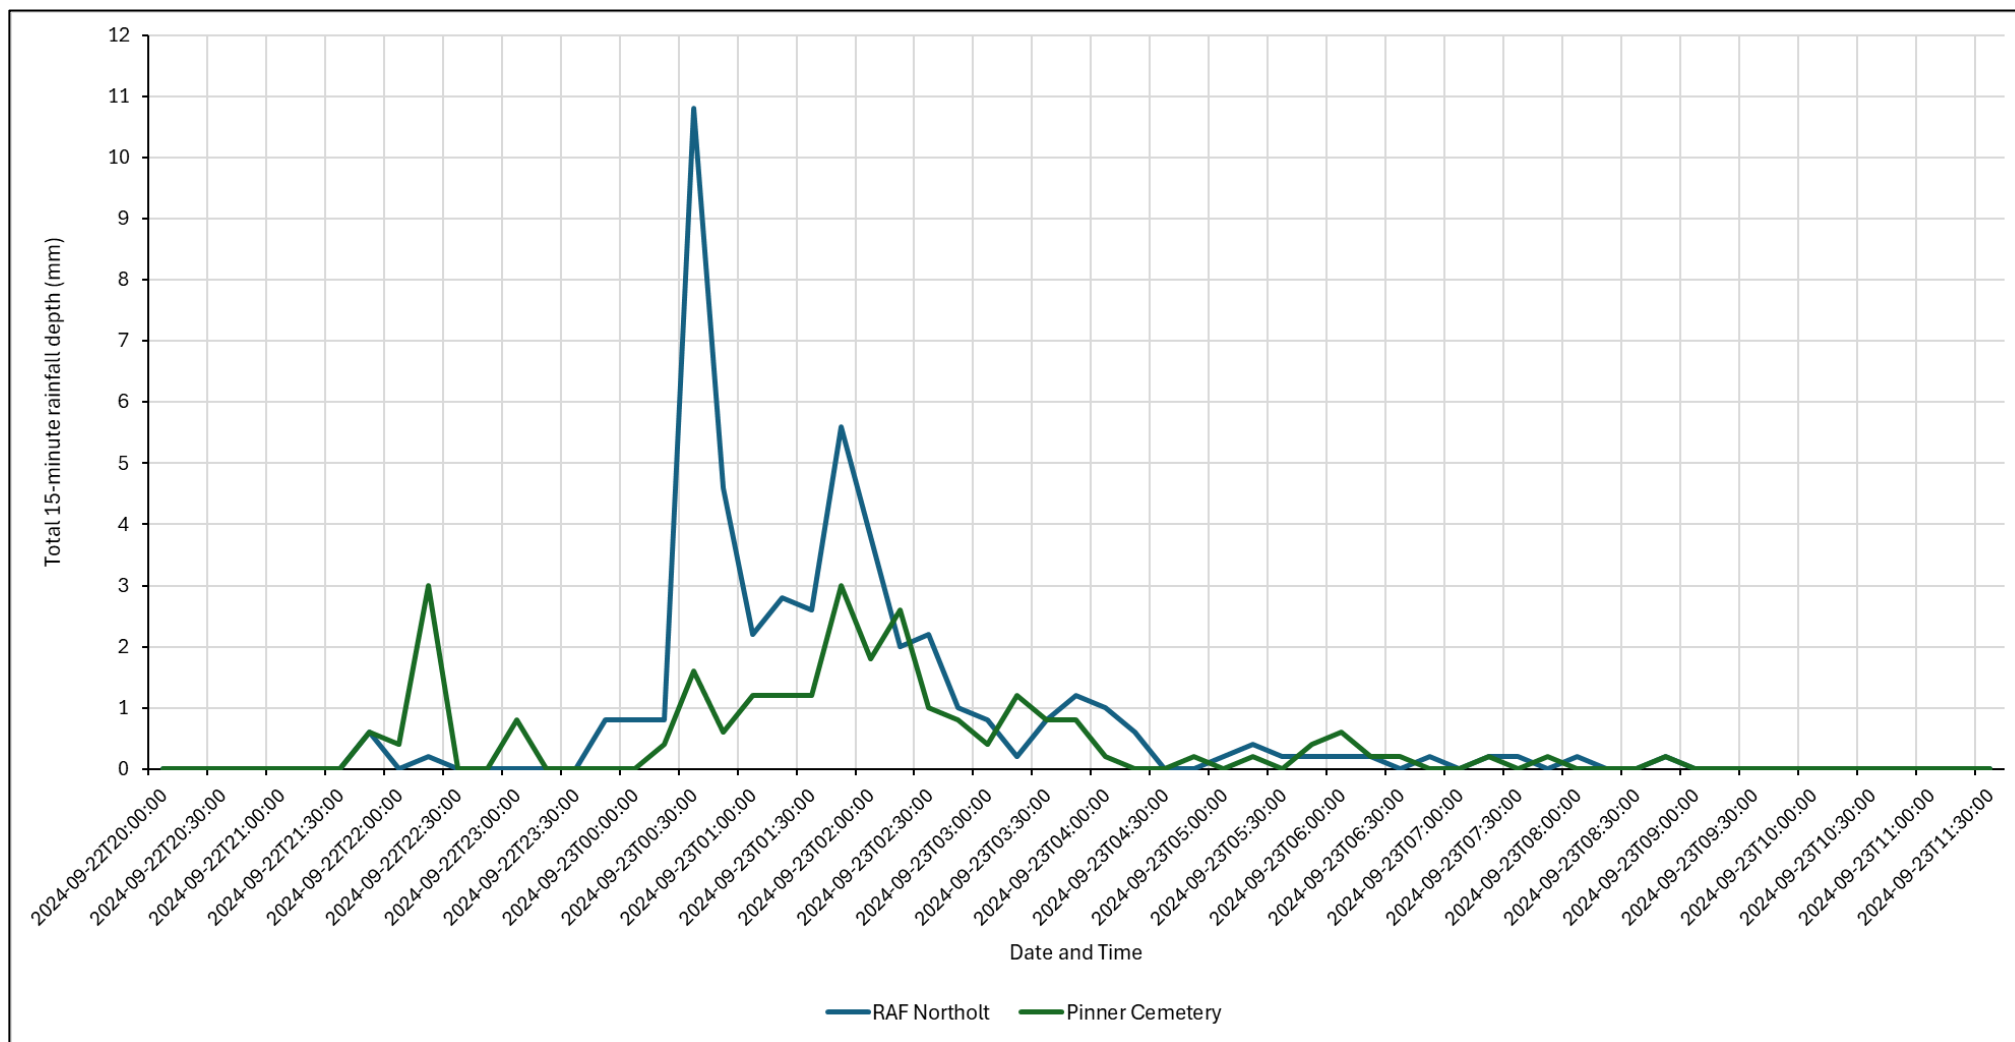
- 3.2.1 Rainfall data recorded by EA rain gauges have been collated for this flood event. The closest rain gauges to the affected areas were found to be RAF Northolt and Pinner Cemetery, their locations are shown below the data in figure 3-5.
- 3.2.2 The data, presented in *Figure 3-1*, shows that the rain began just before 21:45 on the 22 September, peaked around 00:30 on the 23 September, then stopped by 09:00. At the peak, 10.8mm of rain was measured within a 15-minute interval at the RAF Northolt gauge. Over a period of 11 hours and 15 minutes, a total of approximately 47.8mm of rain was received in RAF Northolt and 27.0mm was received in Pinner Cemetery.

Figure 3-1: Rainfall at RAF Northolt and Pinner Cemetery on 22 and 23 September 2024.

7. The data, presented in Figure 3-1, shows that the rain began just before 21:45 on the 22 September, peaked around 00:30 on the 23 September, then stopped by 09:00. At the peak, 10.8mm of rain was measured within a 15-minute interval at the RAF Northolt gauge. Over a period of 11 hours and 15 minutes, a total of approximately 47.8mm of rain was received in RAF Northolt and 27.0mm was received in Pinner Cemetery.
8. Reports of flooding began to be received throughout the early morning of 24 September 2024, largely across locations in Ruislip. There is no single flood reporting system in the Country, so reports were received by various first responders, including the London Fire Brigade, Environment Agency, Thames Water and the Council.
9. A number of reports of internal property flooding were received which triggered the need for a post event Section 19 Flood Investigation.

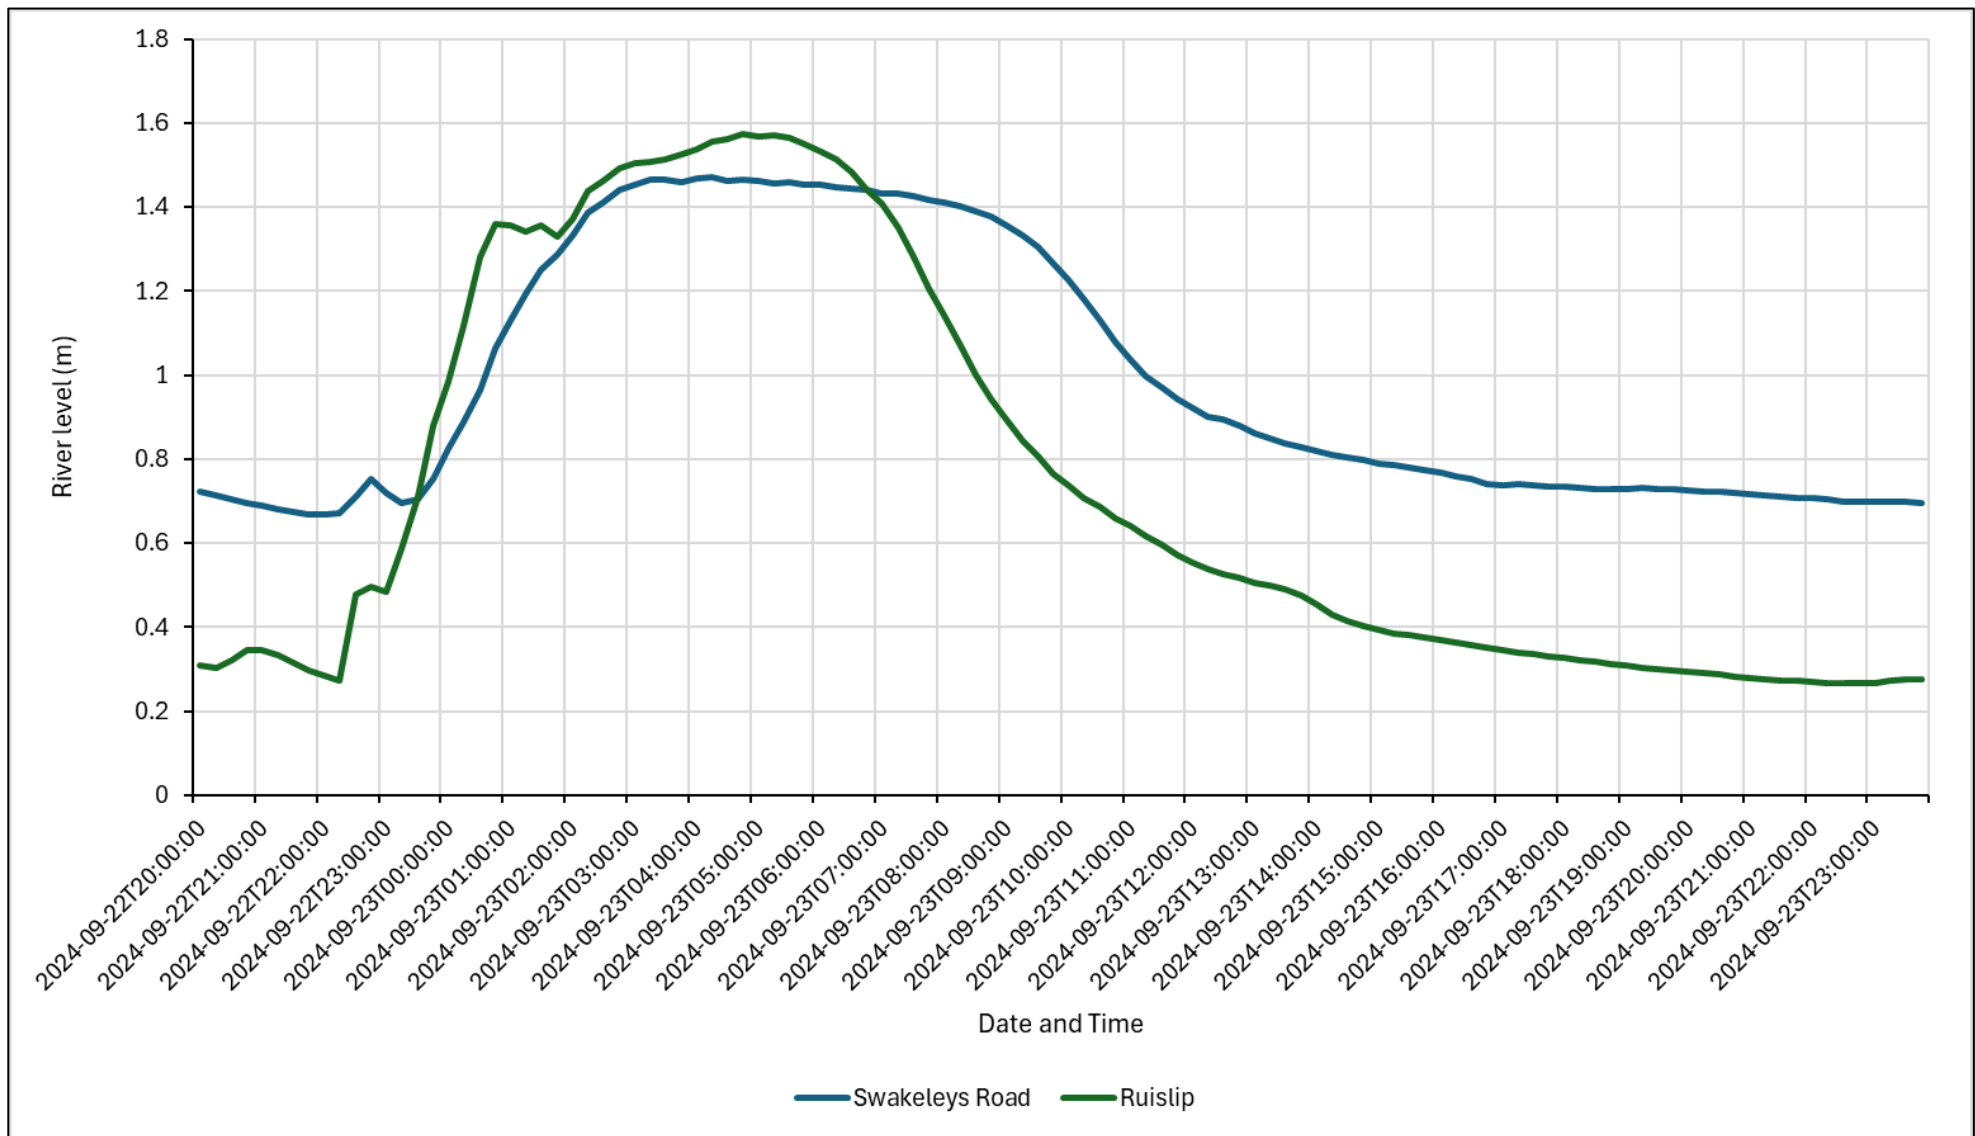
- 3.3.5 It was reported that the River Pinn breached its banks in St George's Field, which is where the Swakeleys Road gauge is located. The Swakeleys Road gauge took notably longer than the Ruislip gauge to record water levels similar to those before the rainfall event. This is likely because the Swakeleys Road gauge is located downstream of the Ruislip gauge, meaning that surface water from a larger proportion of the river basin discharges into the river by this point.

Figure 3-2: River level data from the Ruislip and Swakeleys Road EA gauges on 22 and 23 September 2024.

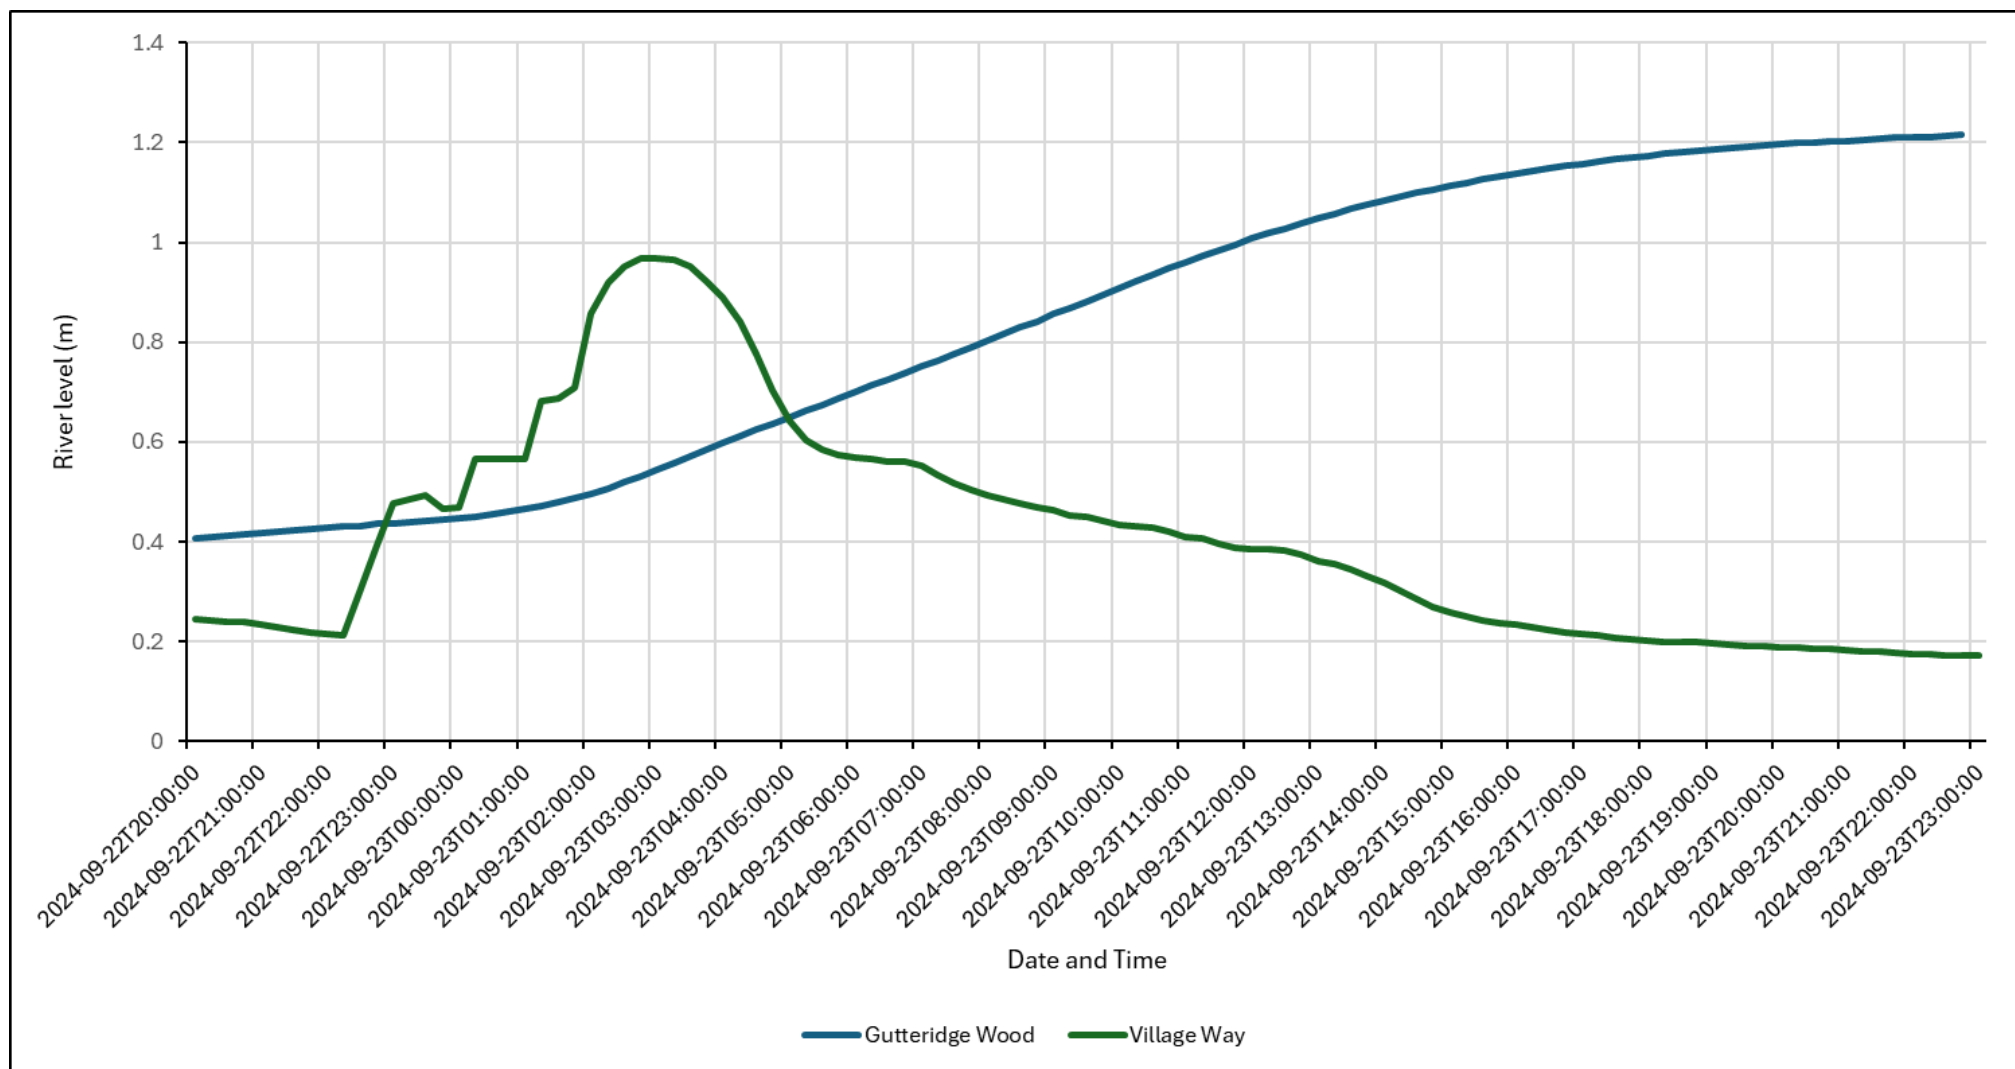
Figure 3-3: River level data from the Village Way and Gutteridge Wood EA gauge on 22 and 23 September 2024.

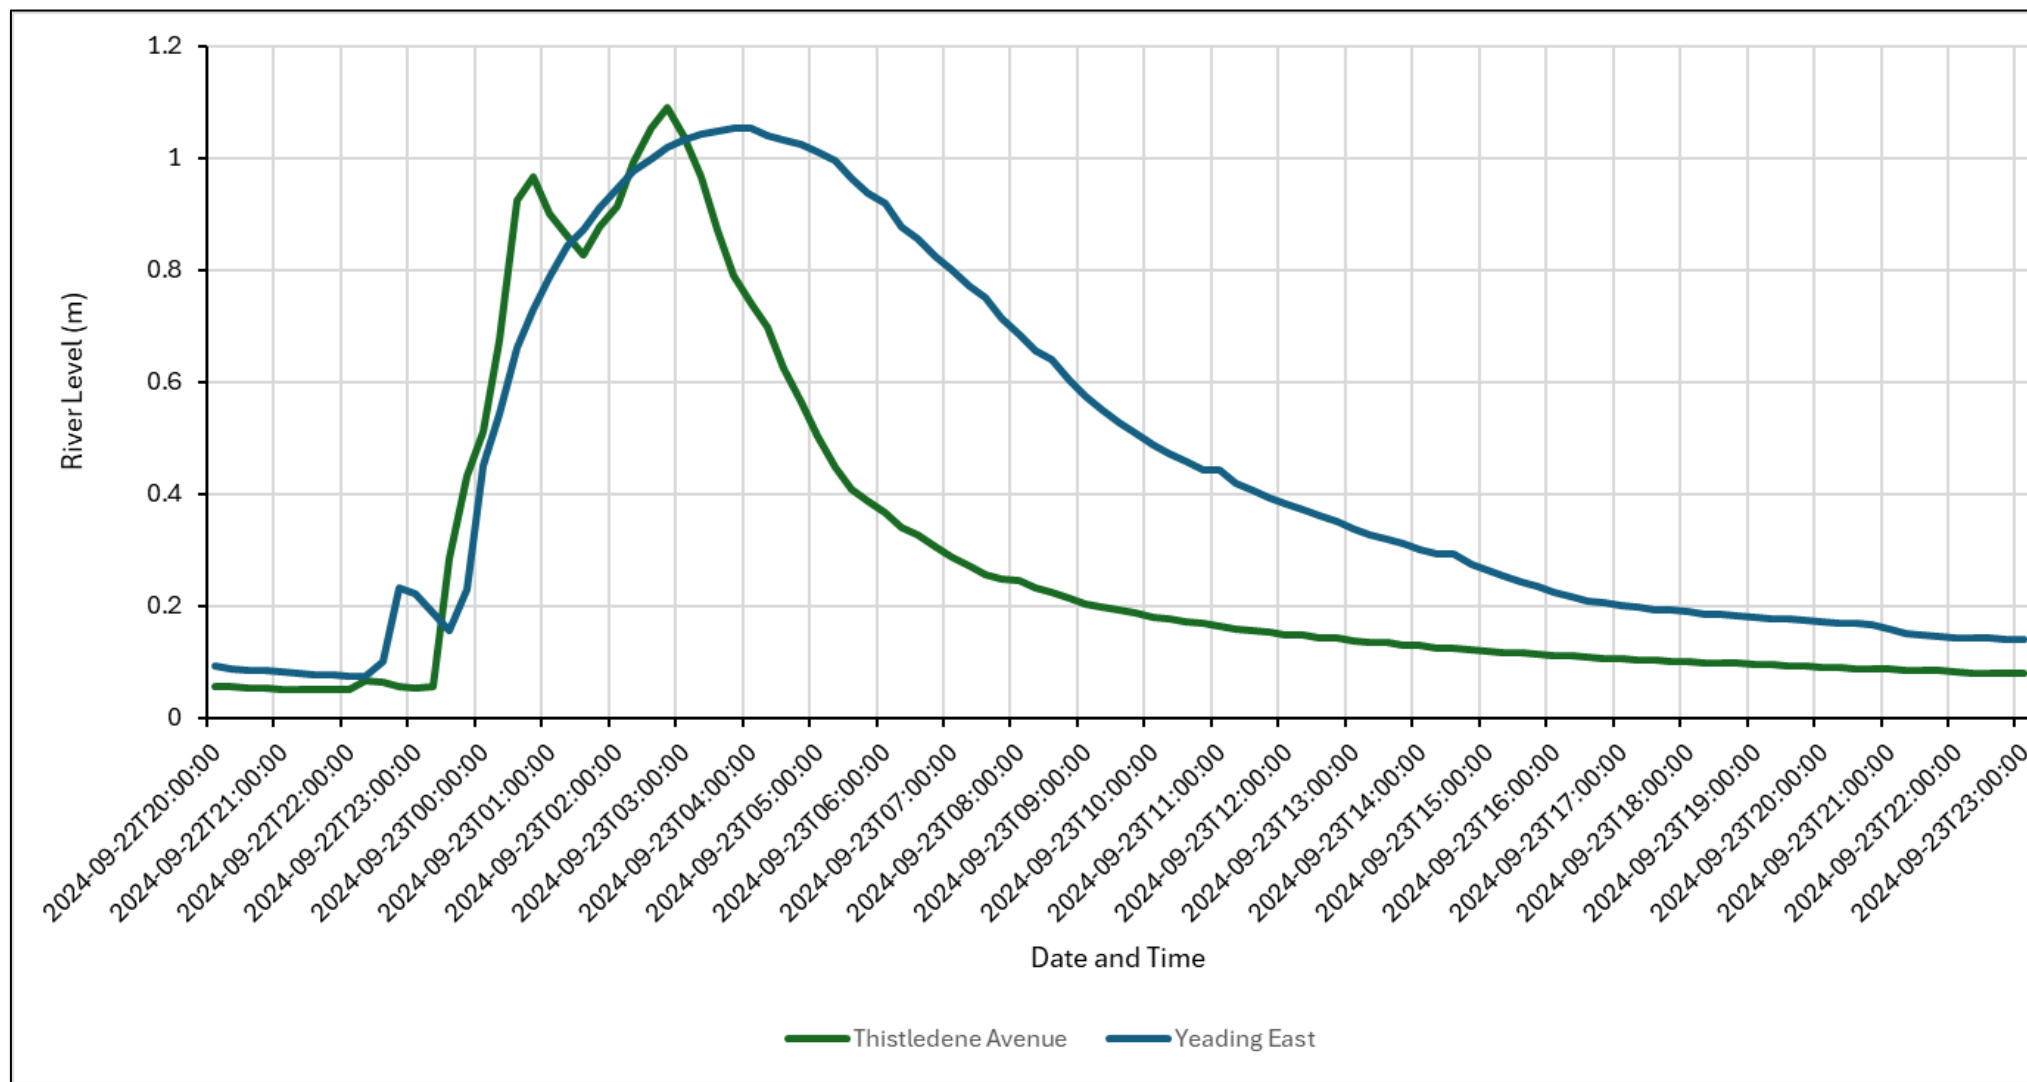
Figure 3-4: River level data from the Thistledene Avenue EA gauge on 22 and 23 September 2024.

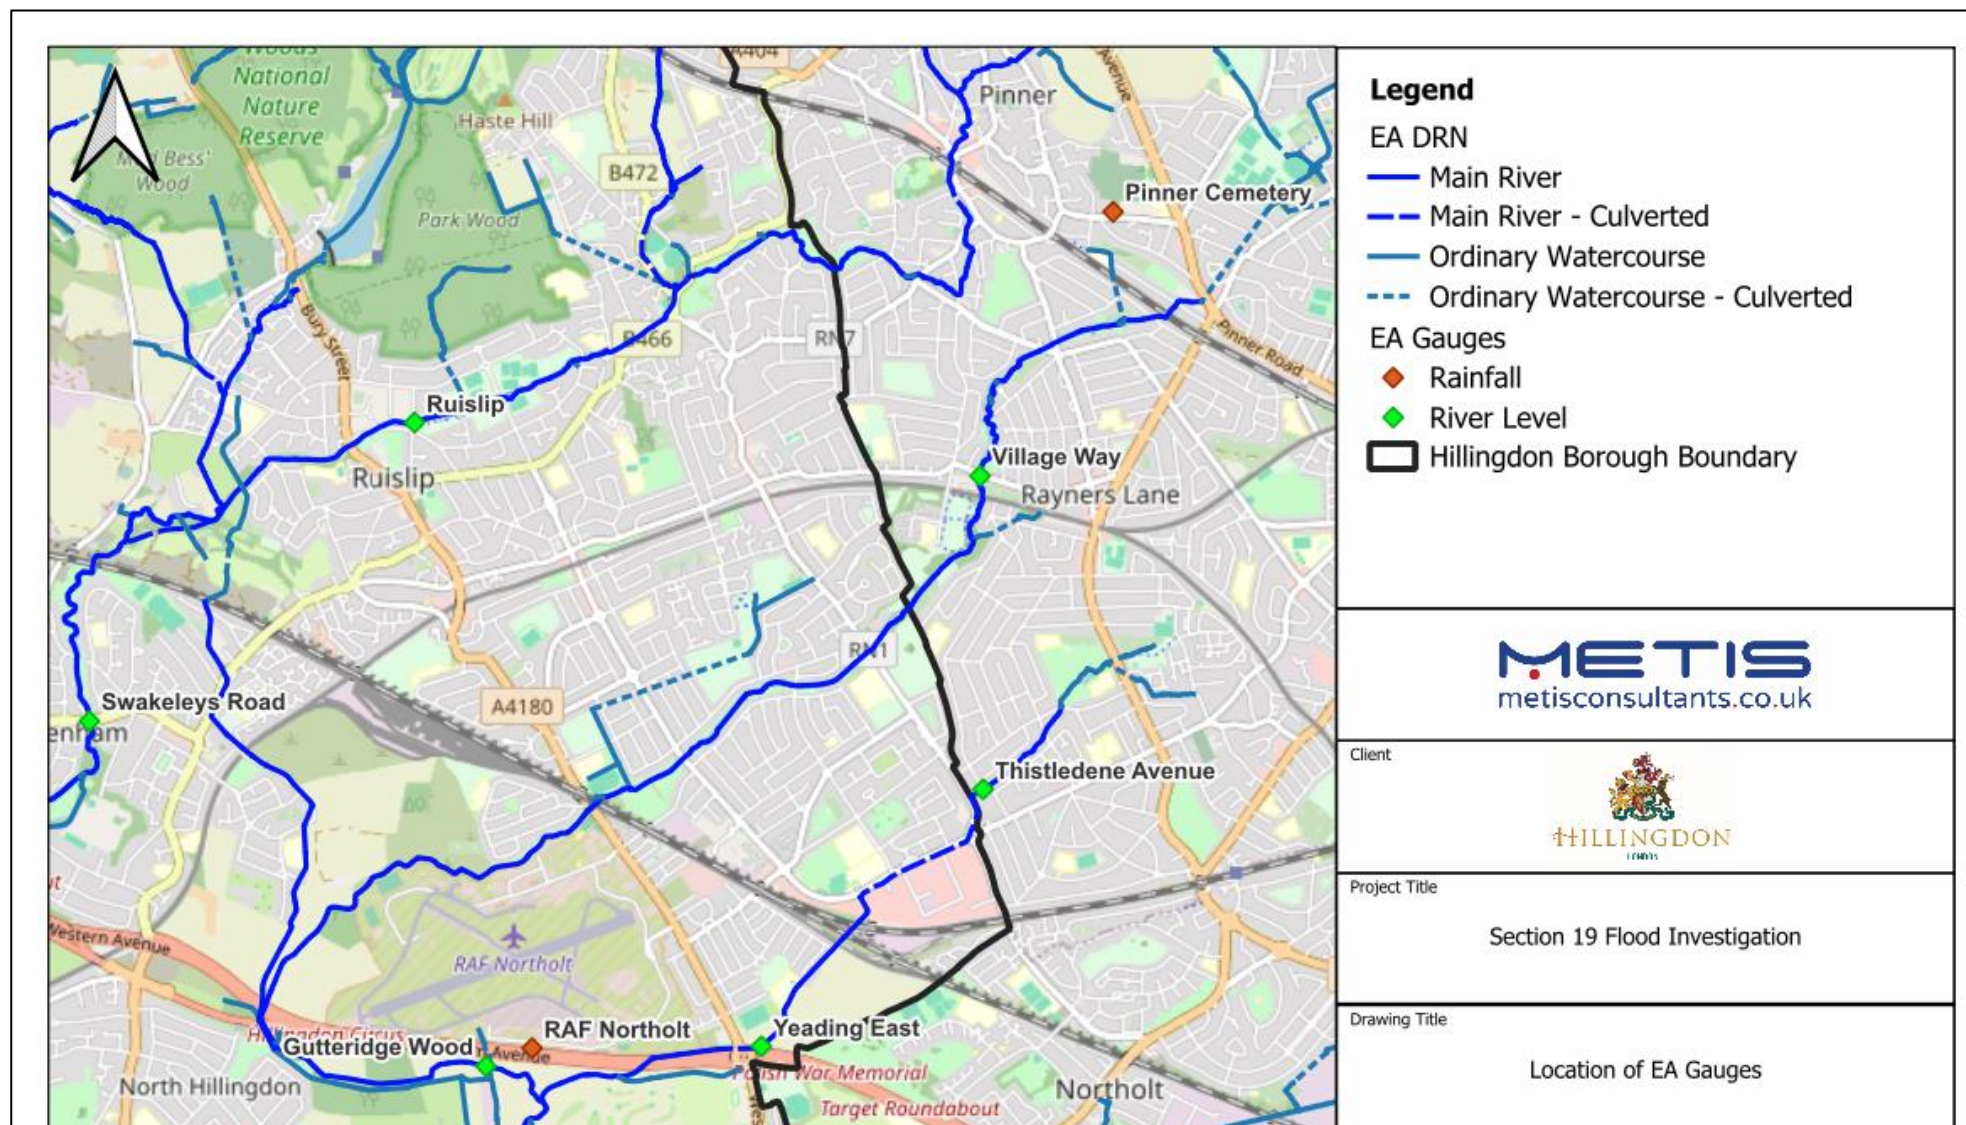
Figure 3-5: Locations of EA gauges discussed in this investigation.

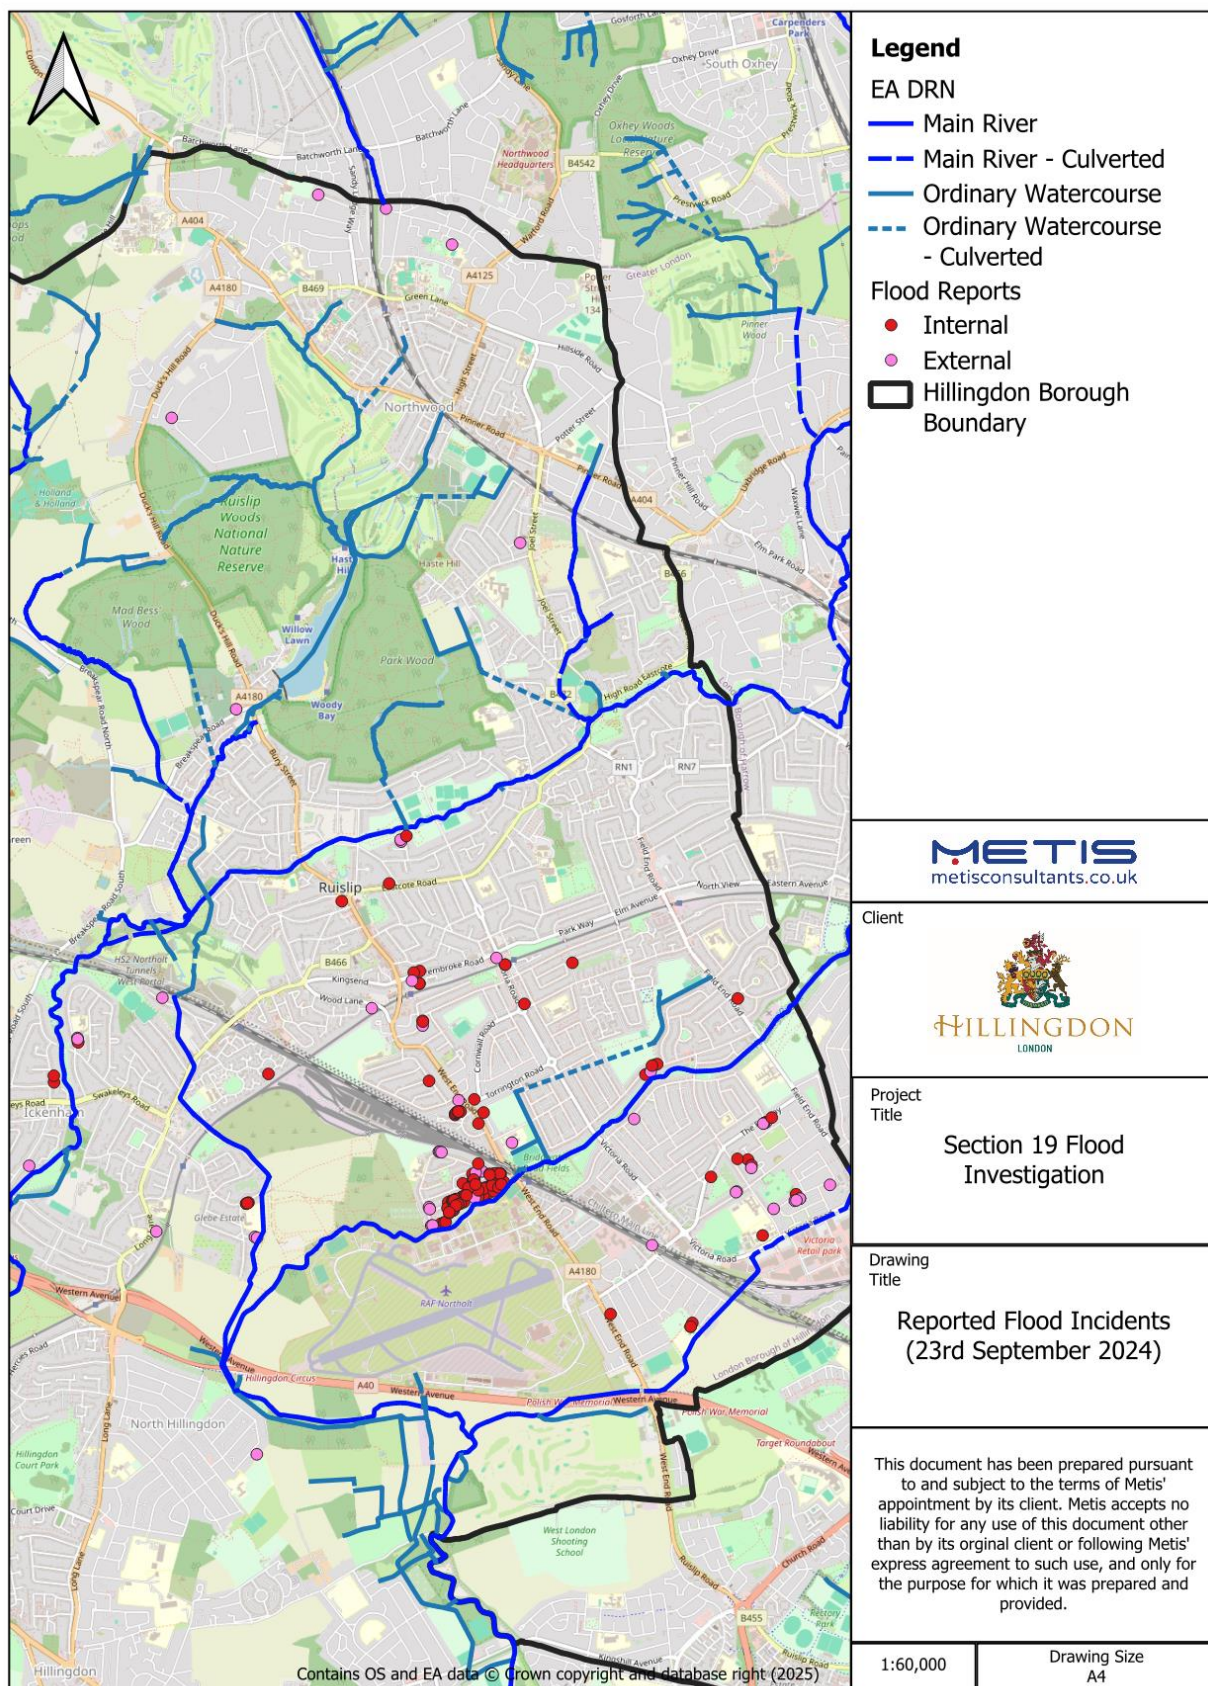
Figure 3-6: Location of reported flood incidents from the 23 September 2024.

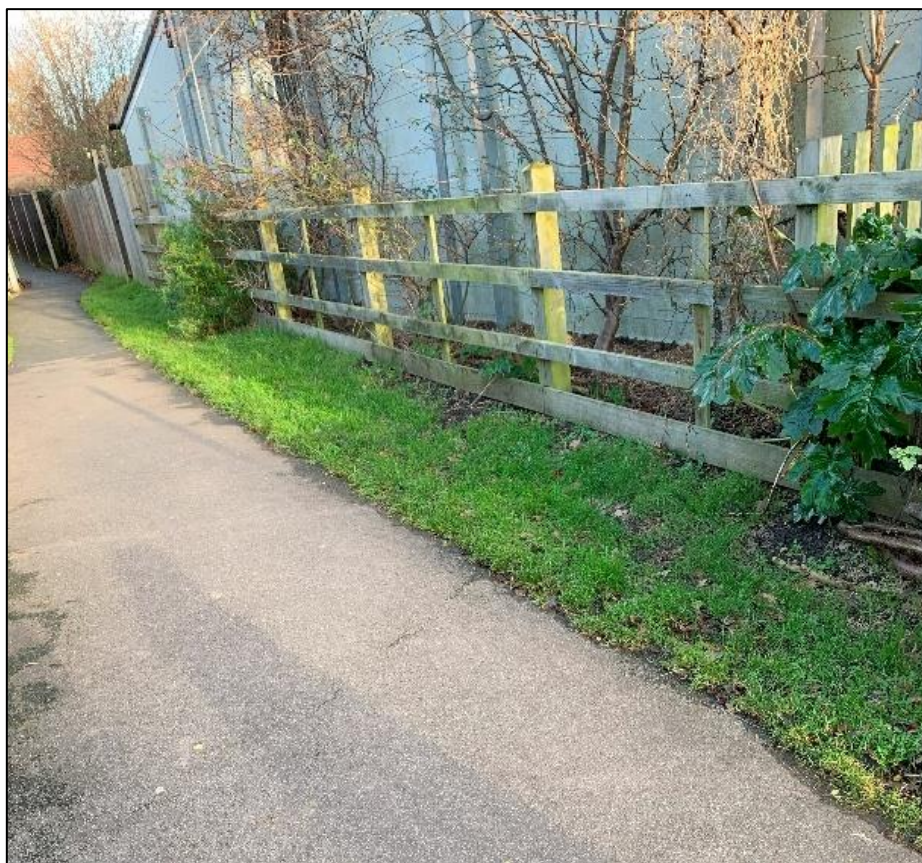
- 5.2.5 There are gullies on both sides of the road at Beech Avenue, however, the gullies closest to the end of the road are not in a position to capture any of the surface water running down the footpath before it reaches Beech Avenue properties. The only green space between Linden Avenue and Beech Avenue is a relatively narrow strip along the western edge of 58 Beech Avenue, pictured in *Figure 5-6*. Therefore, the likely cause of internal flooding along Beech Avenue was due to limited interception from gullies or green spaces resulting in large volumes of surface water flowing from Linden Avenue to Beech Avenue and entering the property through low-lying doors.

Figure 5-6: Photograph of the green space between Linden Avenue and Beech Avenue. Image credit: Metis Consultants Ltd.

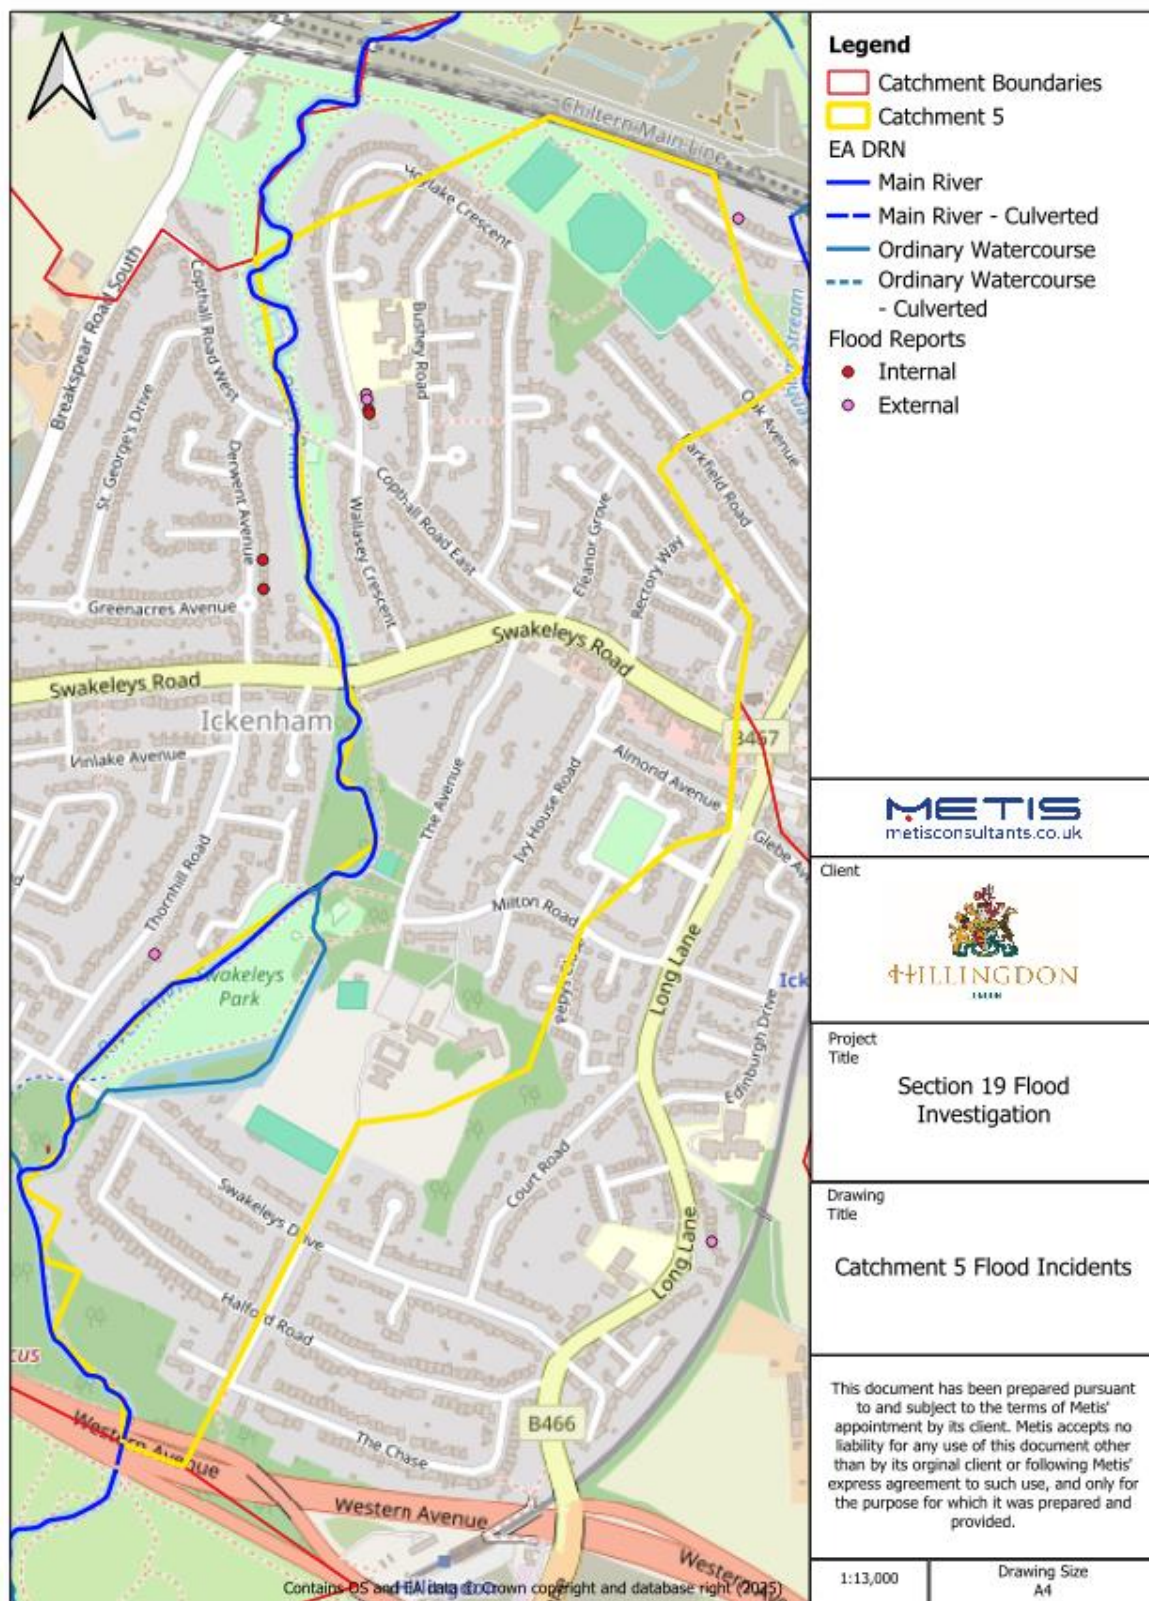
Figure 7-1: Catchment 5 flood incidents from the 23 September flood event.

- 7.1.1 Catchment 5 is located in the centre of Hillingdon and east of Catchment 4. [BGS Geology Viewer](#) shows that the east of this catchment is underlain by London Clay bedrock geology, which is characterised by a low permeability, whilst the west of this catchment is underlain by Lambeth Group bedrock geology, which is characterised by a variable permeability.
- 7.1.2 The catchment is of a mix of residential housing and open green areas, including Swakeleys House Estate, Swakeleys Park, Milton Court and King George's Field. The Breakspear School is also located in this catchment, which installed an astro turf pitch in 2022. The River Pinn runs along the western boundary of the catchment. As shown in figure 7-1, there were two internal flood incidents, and two external flood incidents reported in Catchment 5. The internal flood incidents occurred along Hoylake Crescent.

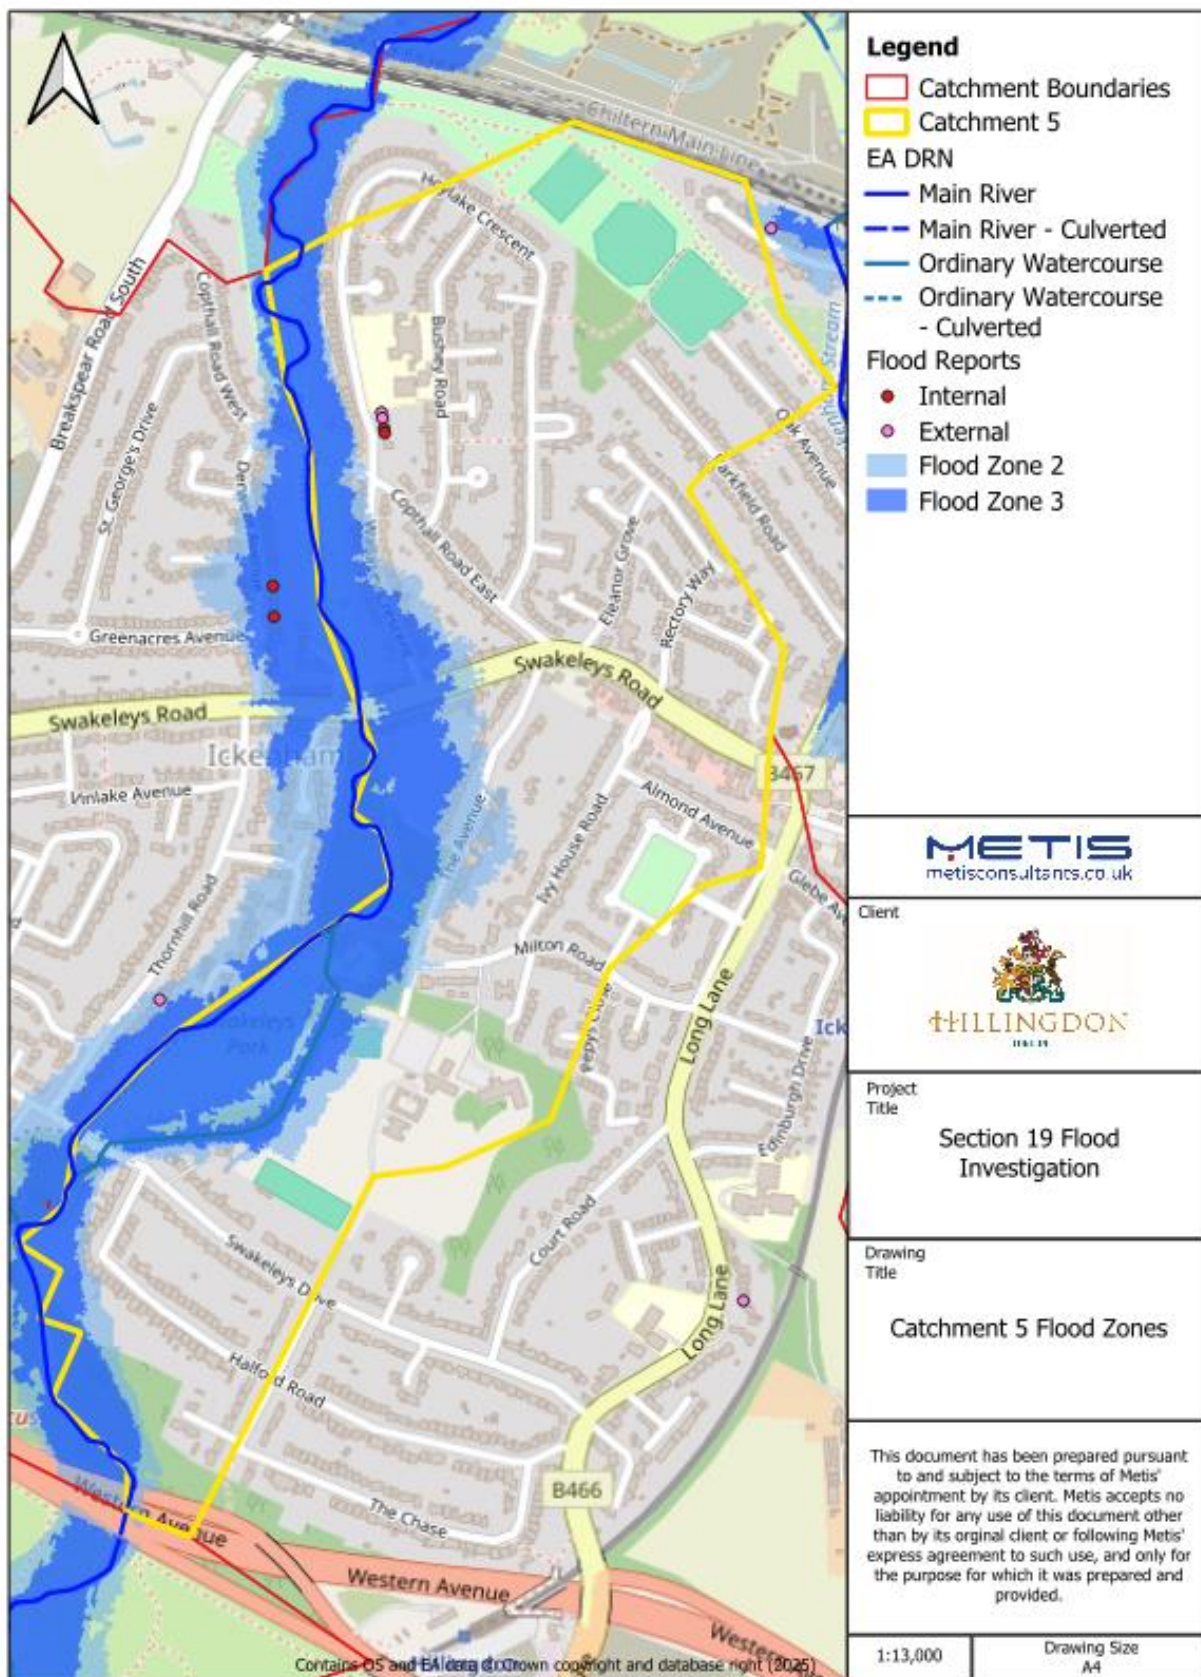
7.1.5 Figure 7-3, a significant area of land along the western boundary of the catchment is in Flood Zone 2 or 3. However, Hoylake Crescent is located in Flood Zone 1.

- 7.1.6 Figure 7-3 also shows that there is an ordinary watercourse in Catchment 5 which branches from the River Pinn and runs through Swakeleys Park before connecting back to the River Pinn. The ordinary watercourse is not located near or upstream of any reported flood incidents.

Figure 7-3: Catchment 5 flood incidents and Flood Zones.

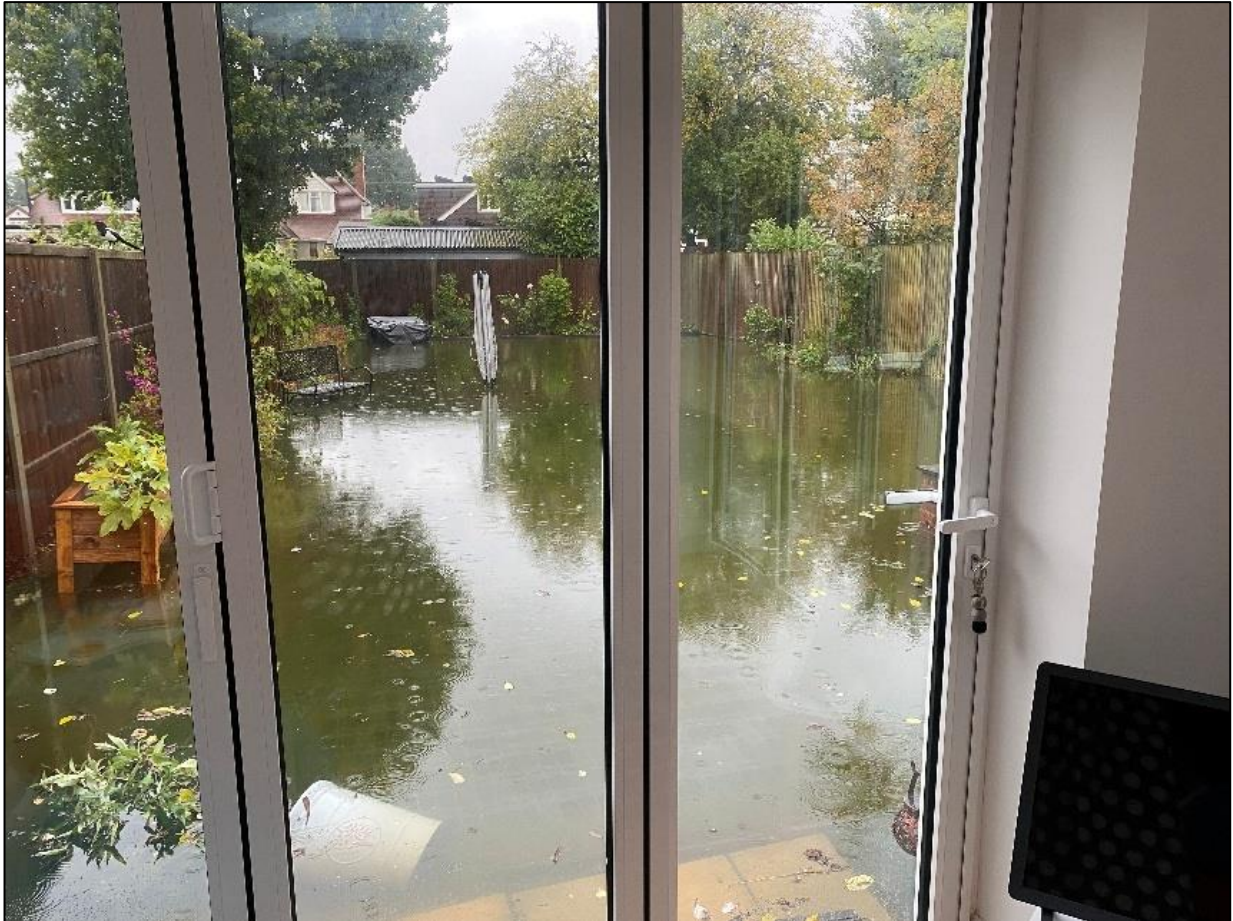
- 7.2.6 Further investigative work is outlined in the recommendations. Ultimately, the rainfall event led to large volumes of surface water flowing through the back gardens of Hoylake Crescent properties towards the River Pinn, as shown in *Figure 7-5*. This water was reportedly able to enter two Hoylake Crescent properties through low-lying airbricks and back doors. Property level resilience measures should be considered for these properties.

Figure 7-5: Photograph of surface water flooding to the back garden of a Hoylake Crescent property on the 23 September 2024. Image credit: Hoylake Crescent resident.

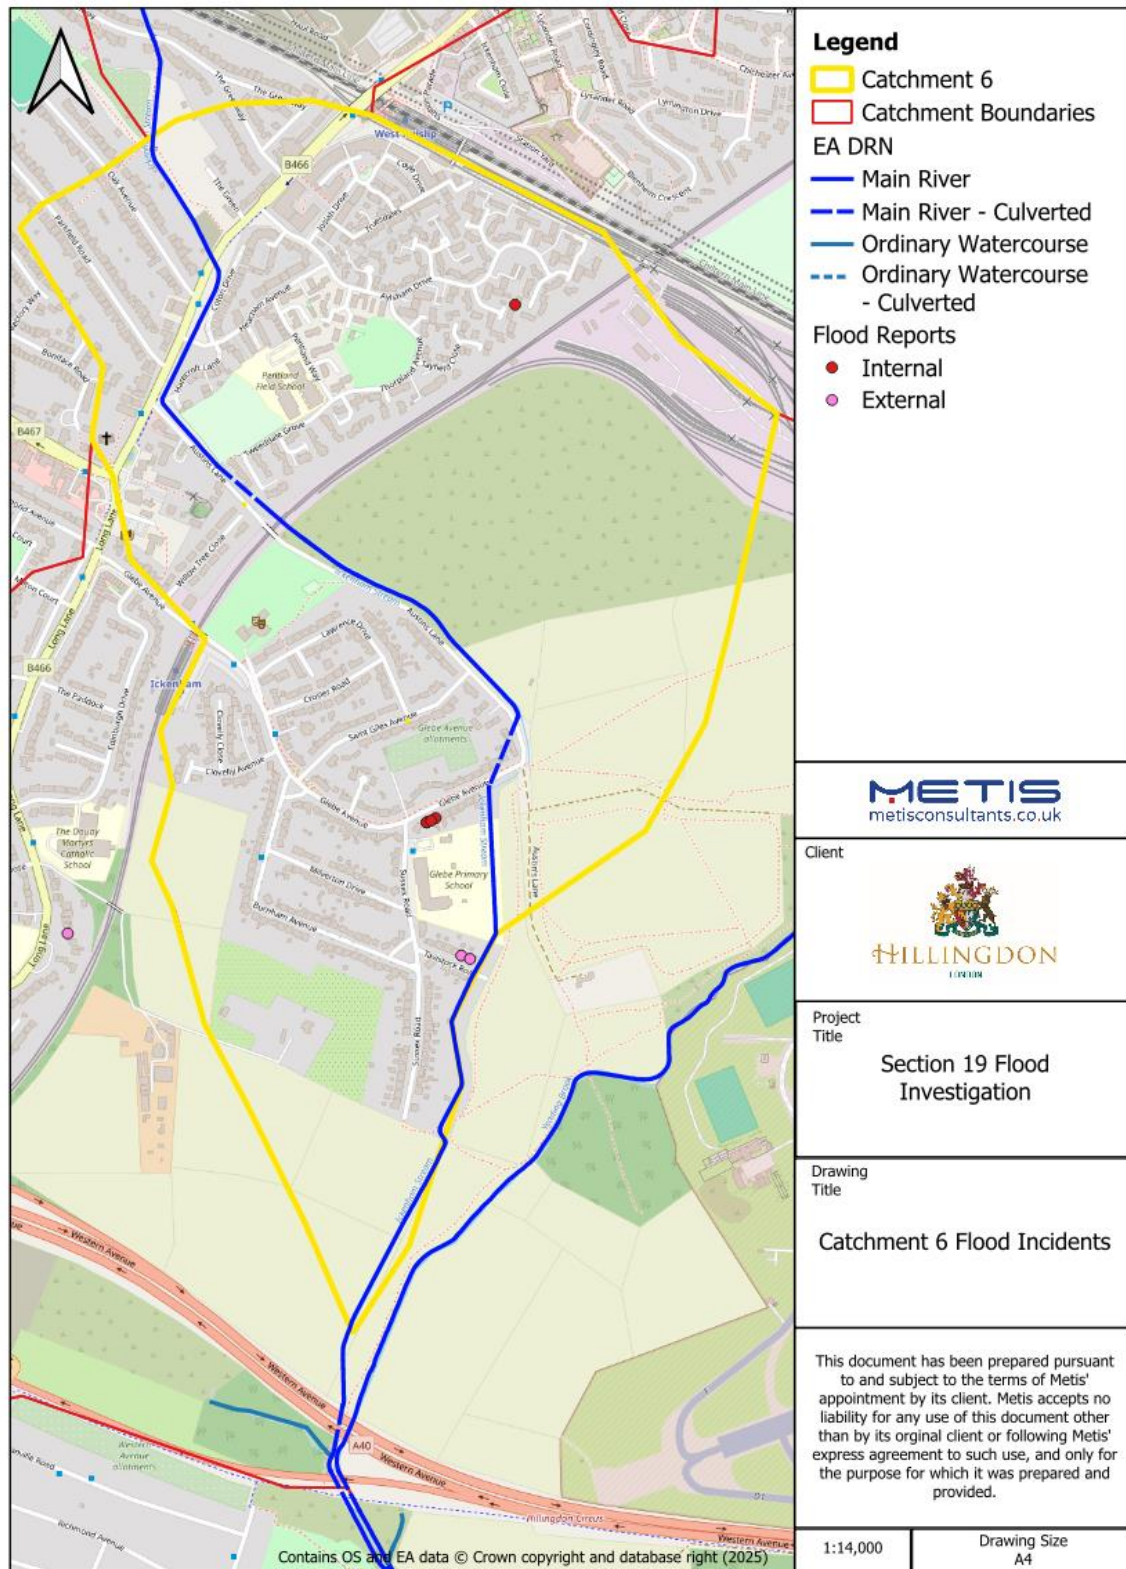
Figure 8-1: Catchment 6 flood incidents from the 23 September 2024 flood event.

- 8.1.1 Catchment 6 is located in the centre of Hillingdon and east of Catchment 5. BGS Geology Viewer shows that this catchment is underlain by London Clay bedrock geology, which is characterised by a low permeability. The catchment consists of a mix of residential housing and a large open green space called Ickenham Marsh. Glebe Primary School is also located in this catchment. The Ickenham Stream runs from the north-east to the south-west of this catchment. As shown figure 8-1, there were four internal flood incidents, and two external flood incidents reported in Catchment 6. The internal flood incidents occurred along Glebe Avenue and Aylsham Drive.
