SECTION 19 FLOOD INVESTIGATION: SEPTEMBER 2024 FLOOD EVENT

23 September 2024 Flood Event

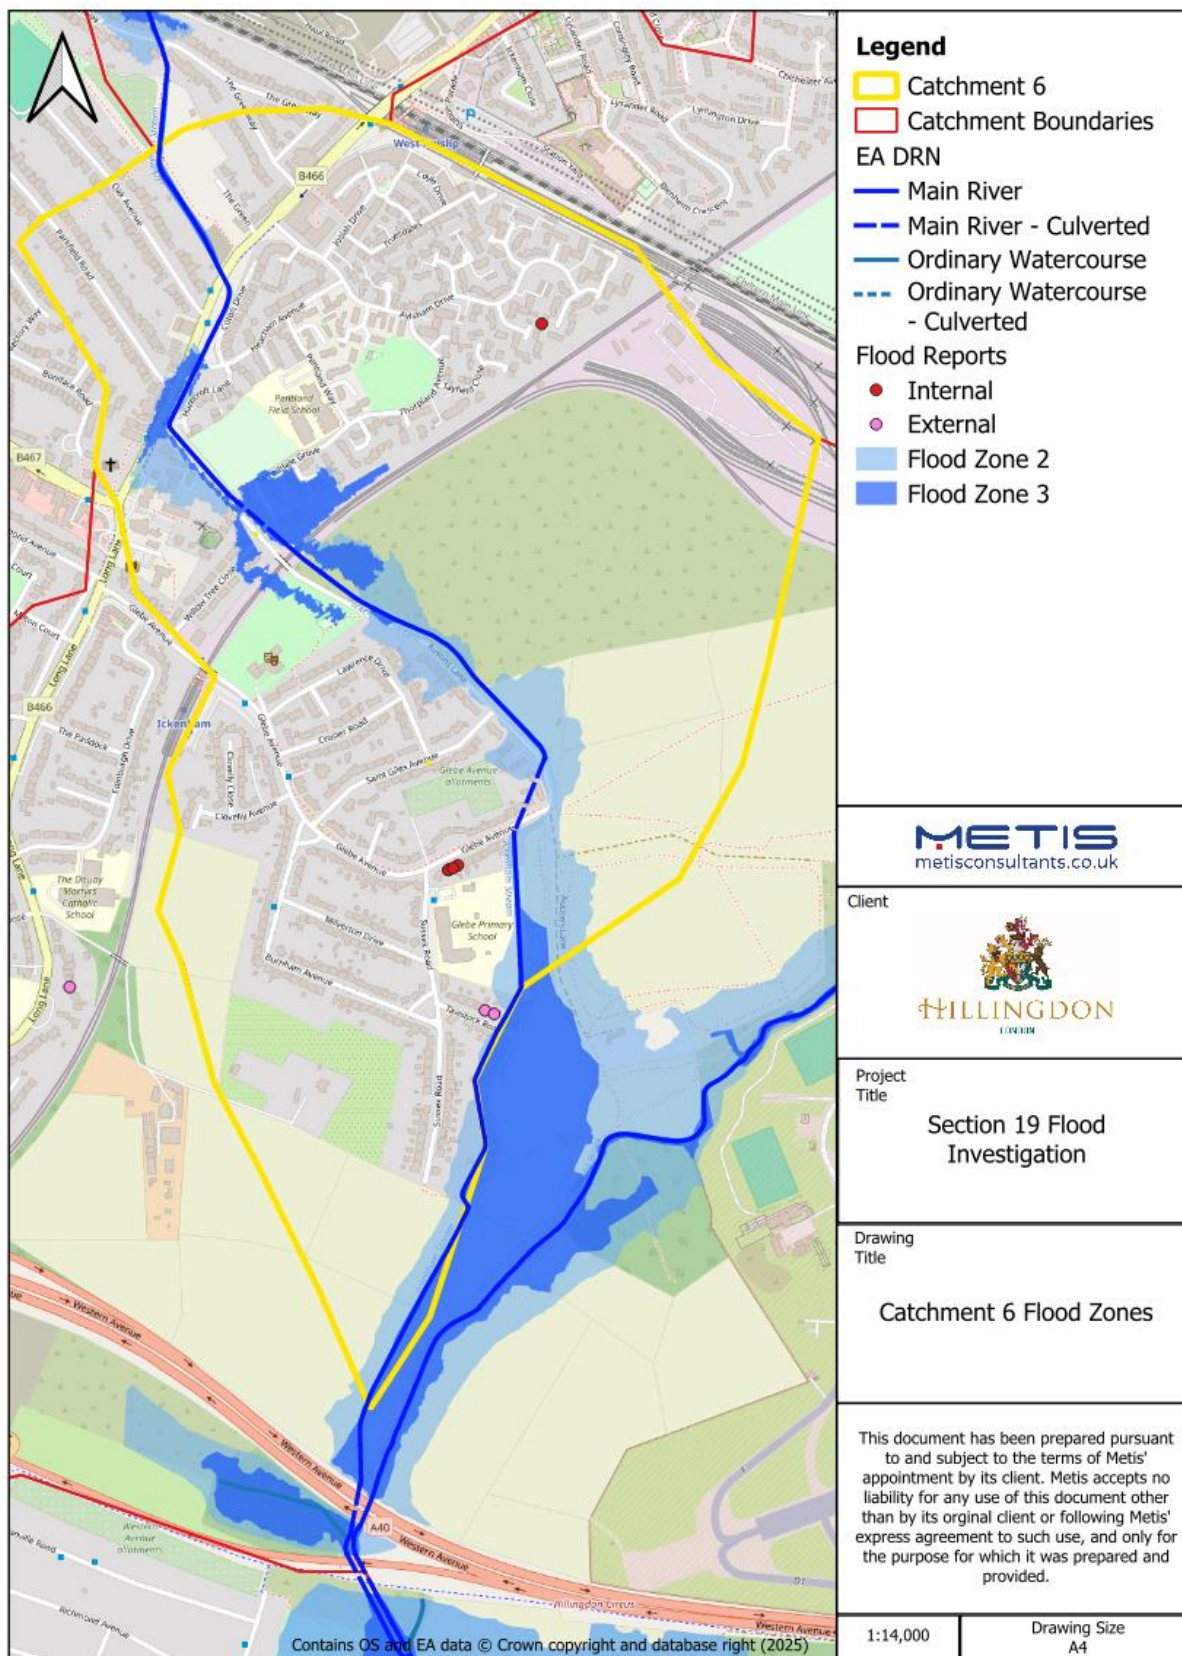
8.1.3 Figure 8-3 shows that, in the north of the catchment, Flood Zone 2 and 3 runs parallel with the Icknham Stream, and extends over properties along High Road Icknham, Tweeddale Avenue, Nithsdale Grove, and Austins Lane. Further south in the catchment, Flood Zone 2

Figure 8-3: Catchment 6 flood incidents and Flood Zones.

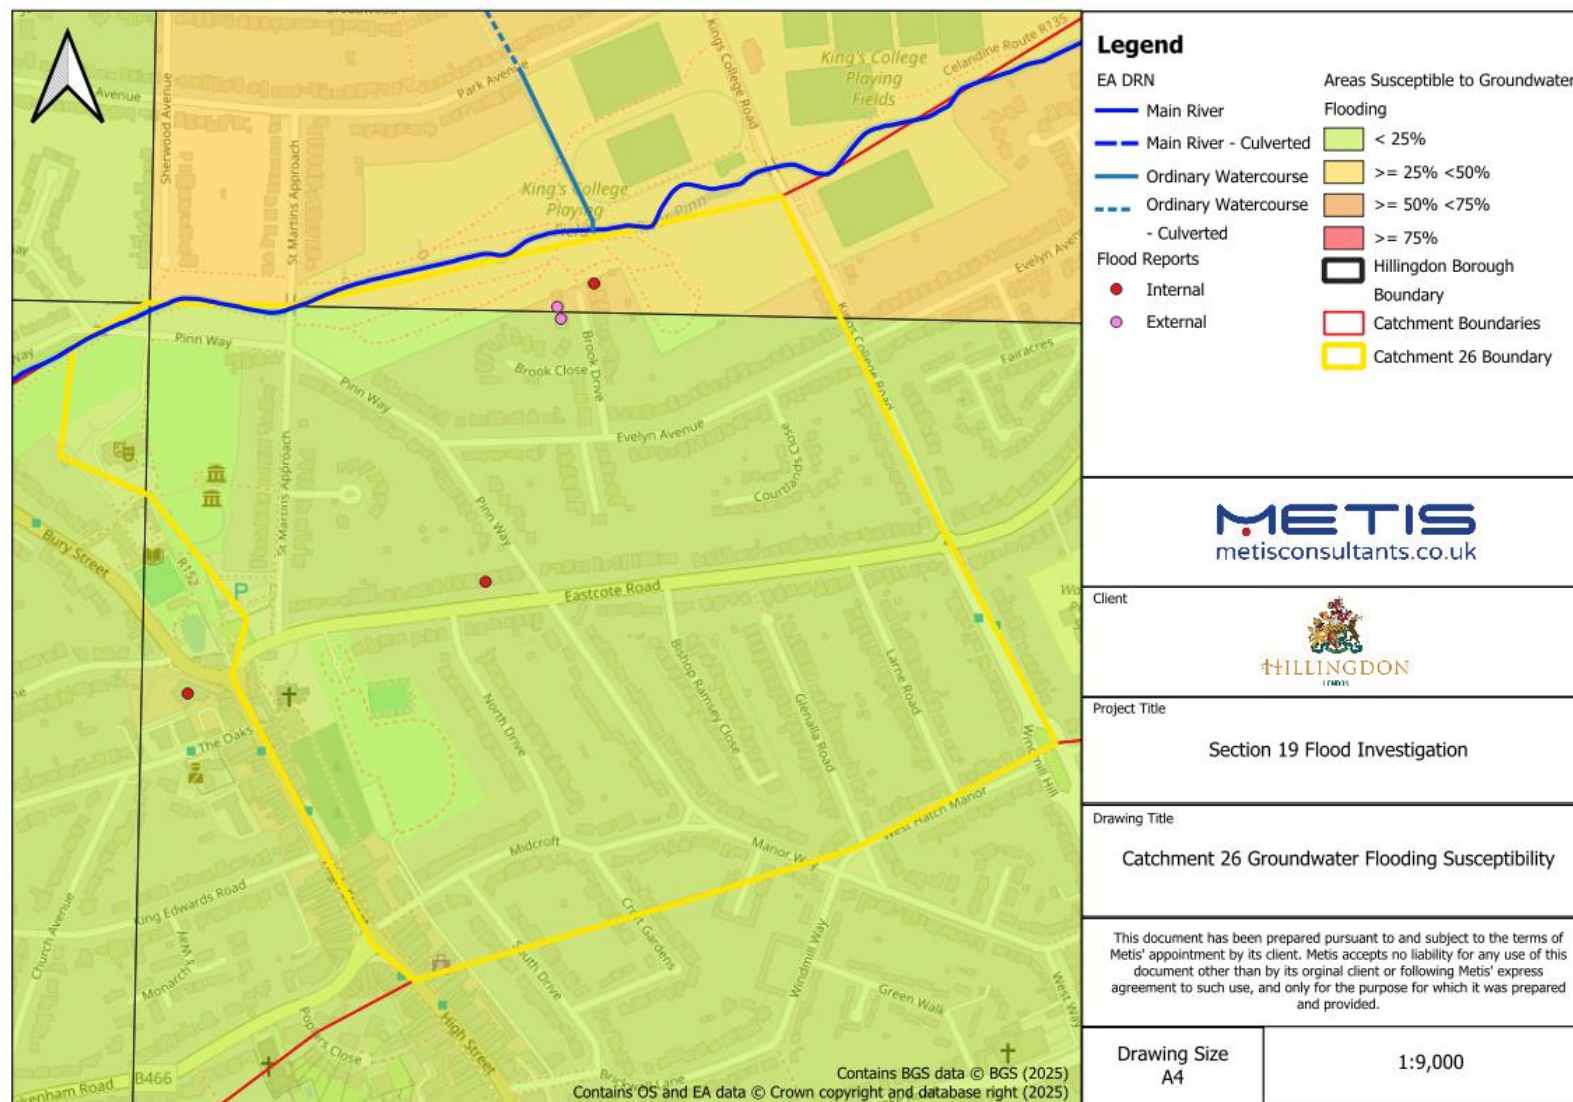
- 11.1.7 Figure 11-4 shows that the majority of the catchment is at less than 25% susceptibility to groundwater flooding. A small area in the north which includes Pinn Meadows, and some Brook Drive properties is classified as between 25% and 50% susceptible to groundwater flooding. Whilst, the groundwater may not result directly in flooding, it contributes to the excess amount of water in the catchment that struggles to be accommodated in either the river, drainage network, or open spaces.

Figure 11-4: Catchment 26 flood incidents and groundwater flooding susceptibility.

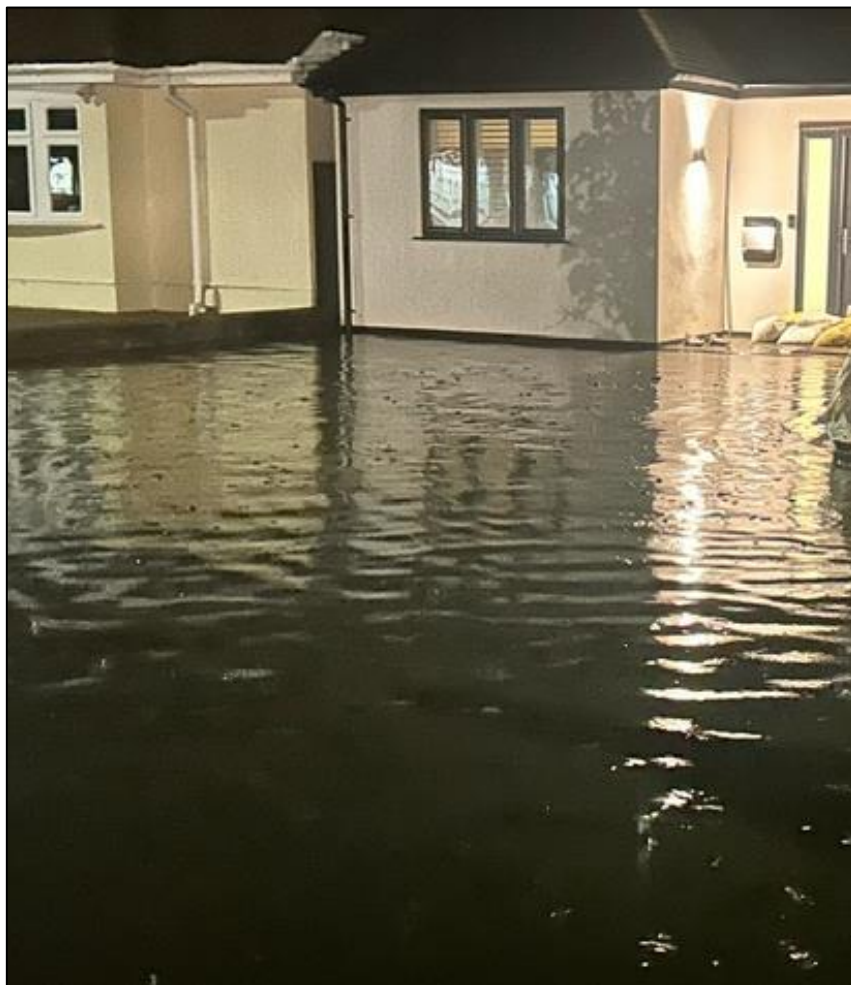
Figure 11-6: Photograph of fluvial flooding along Brook Drive on the 23 September 2024. Image credit: Brook Drive resident.
